UNDERWATER BRIDGE INSPECTION REPORT

STRUCTURE NO. 86515
CSAH NO. 42
OVER THE
MISSISSIPPI RIVER
DISTRICT 3 - WRIGHT COUNTY

PREPARED FOR THE
MINNESOTA DEPARTMENT OF TRANSPORTATION
BY
COLLINS ENGINEERS, INC.
JOB NO. 3512 (CEI 102)

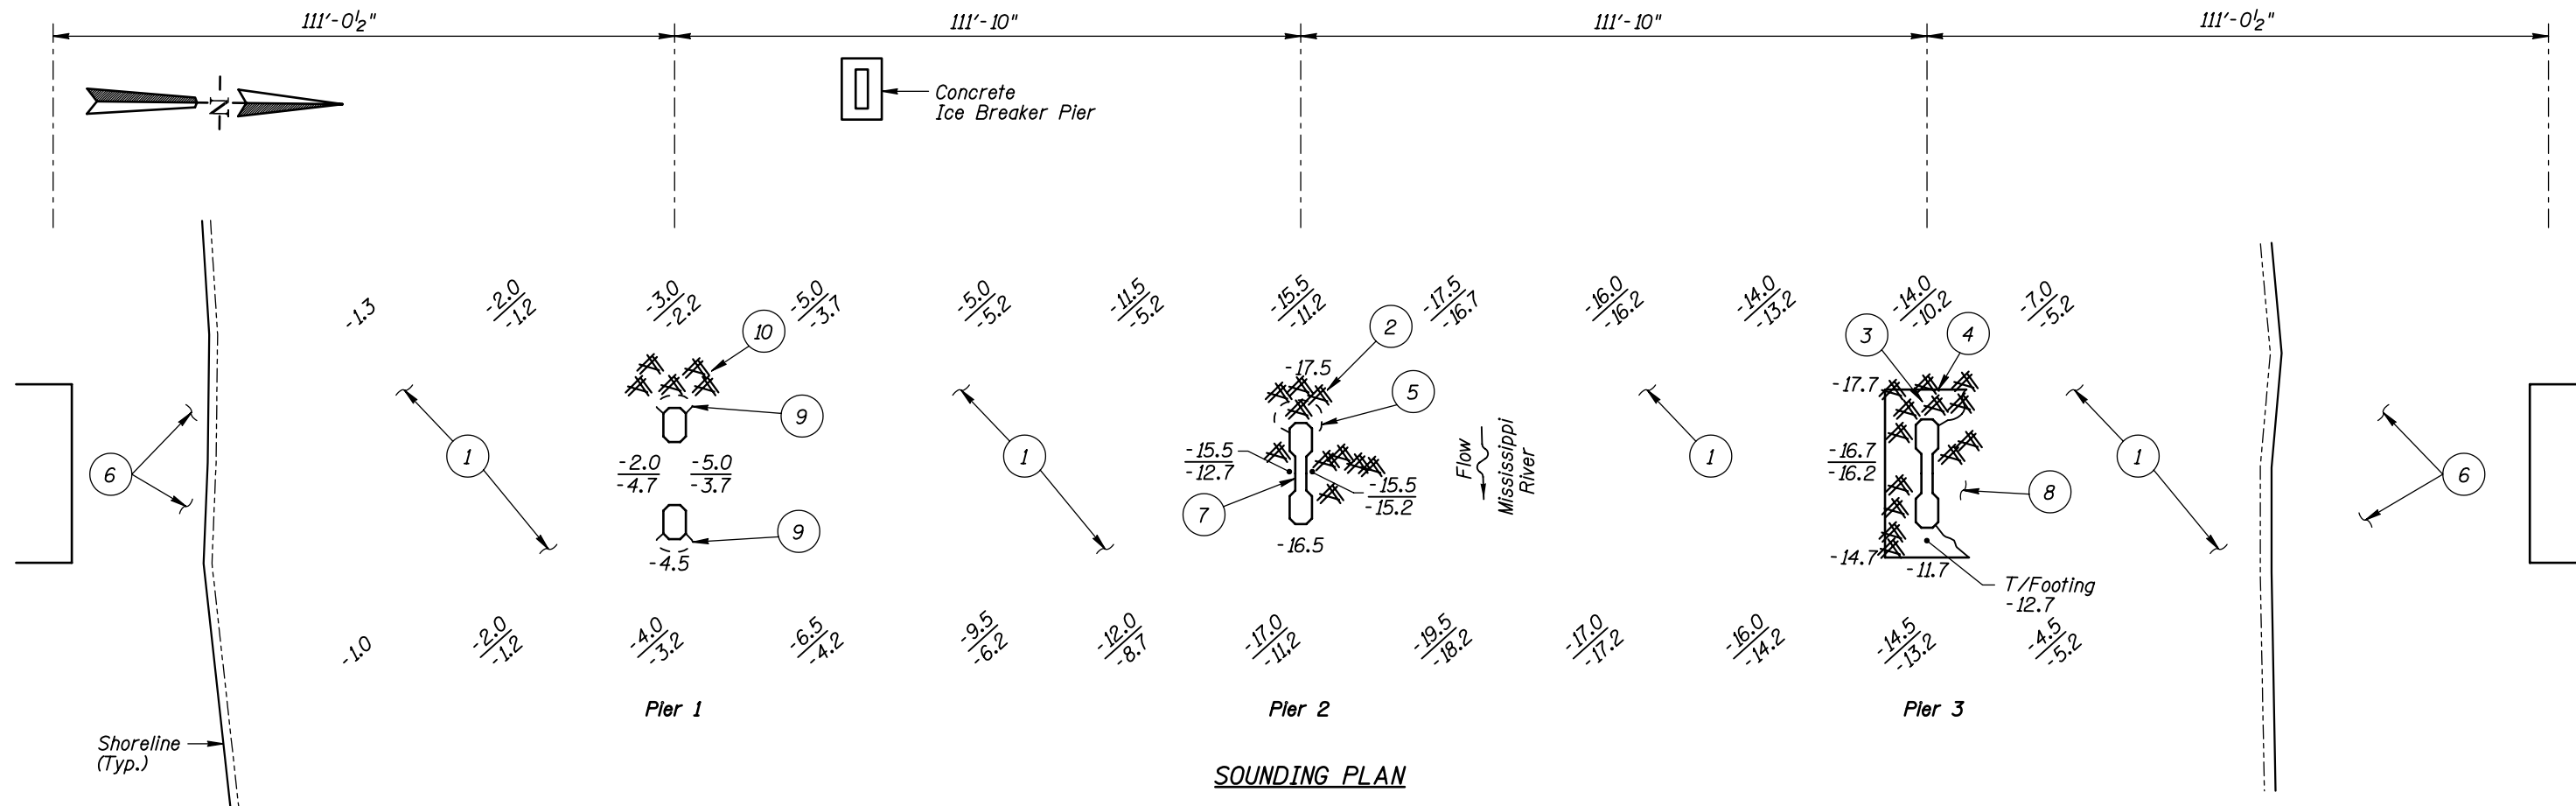
INSPECTION AND SOUNDING PLAN

- 1 The channel bottom material consisted of sand, gravel and scattered cobbles, 1-foot-diameter and smaller, with up to 1 foot of probe rod penetration.

- 2 A moderate accumulation of 10-inch-diameter and smaller timber debris was observed around the upstream nose extending along the north face from 12 feet below the waterline to the channel bottom.

- 3 A heavy accumulation of 2-foot-diameter and smaller timber debris was observed at the upstream end of the pier extending from the channel bottom to the waterline.

- 4 The top of the footing was exposed with 5 feet of vertical face exposure at the upstream end, 4 feet along the west side, and 1 foot along the downstream end. There was also 6 inches of undermining along the upstream nose of the footing with 1 foot of probe rod penetration under the footing and with no piles exposed.

- 5 A 5-foot-radius, 2-foot-deep scour pocket was observed at the upstream nose of the pier.
- 6 The embankments consisted of 1- to 2-foot-diameter riprap.

- 7 A horizontal steel H-pile strut was observed 10 feet below the waterline and protruded 4 inches from each side of the web wall. There was no associated spalling present.

- 8 Sand infilling with cobbles was observed along the east face of the pier.

- 9 A 4-foot-radius, 1-foot-deep scour pocket was observed at the upstream and downstream ends of the pier.
- 10 A light accumulation of 10-inch-diameter and smaller timber debris was observed at the upstream end of the pier.

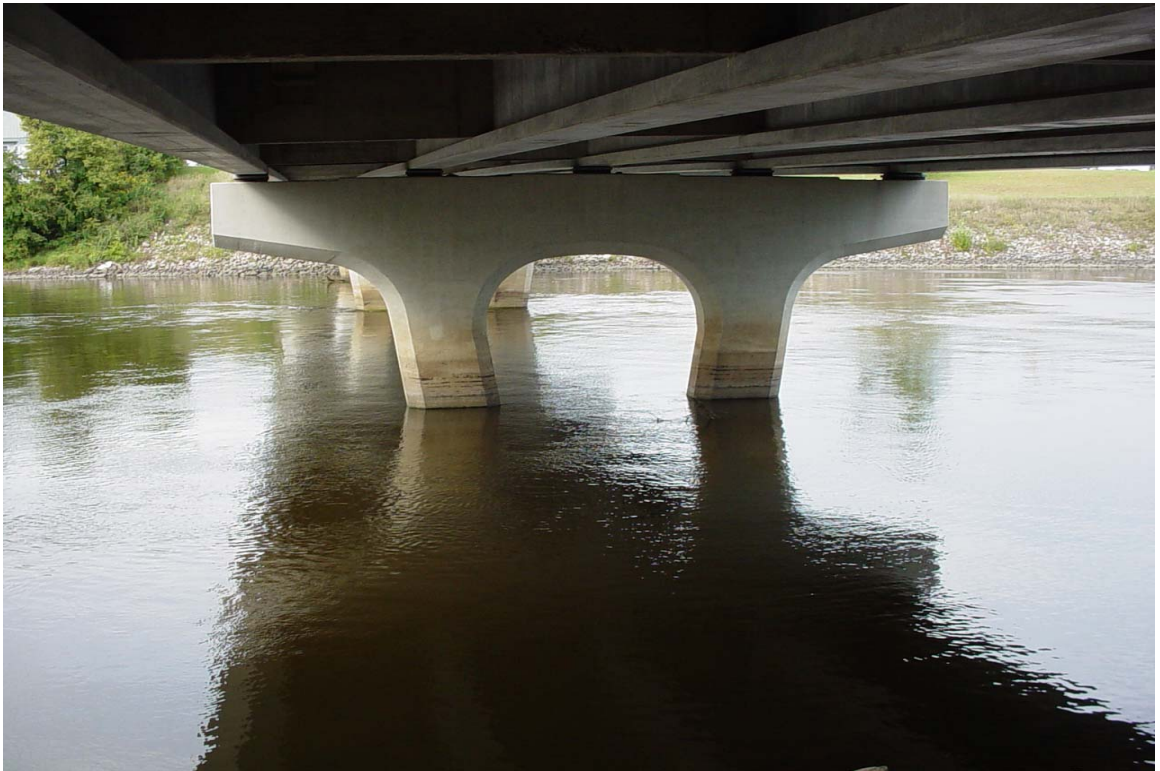
- (C) Since the previous inspection, a 5-foot-radius by 2-foot-deep scour depression has developed at the upstream end of Pier 2. There were also 4-foot-radius by 1-foot-deep scour depressions at both the upstream and downstream ends of Pier1.

Photograph 2. View of Pier 1, Looking North.

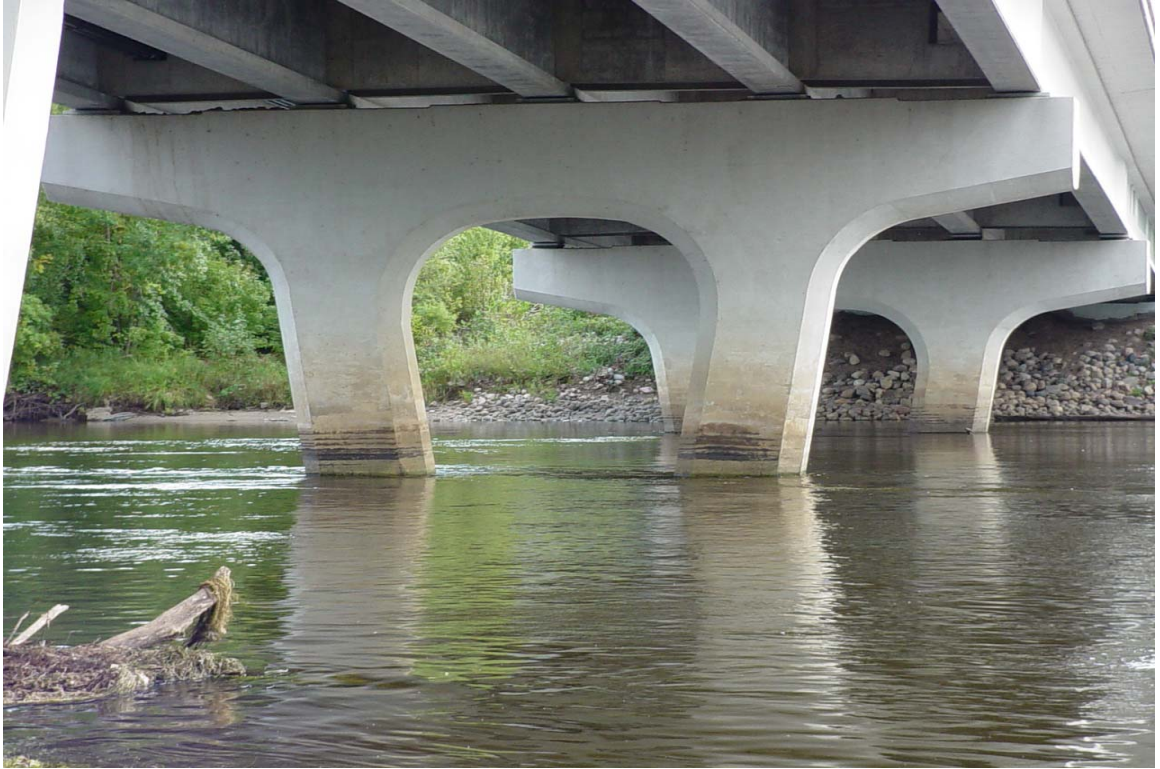
- (B) Moderate to heavy accumulations of timber debris were observed around the upstream noses of Piers 2 and 3, respectively, and a light accumulation of timber debris was observed at the upstream nose of Pier 1.

Photograph 3. View of Pier 2, Looking South.

Remove the accumulation of timber debris around the piers during routine bridge maintenance.

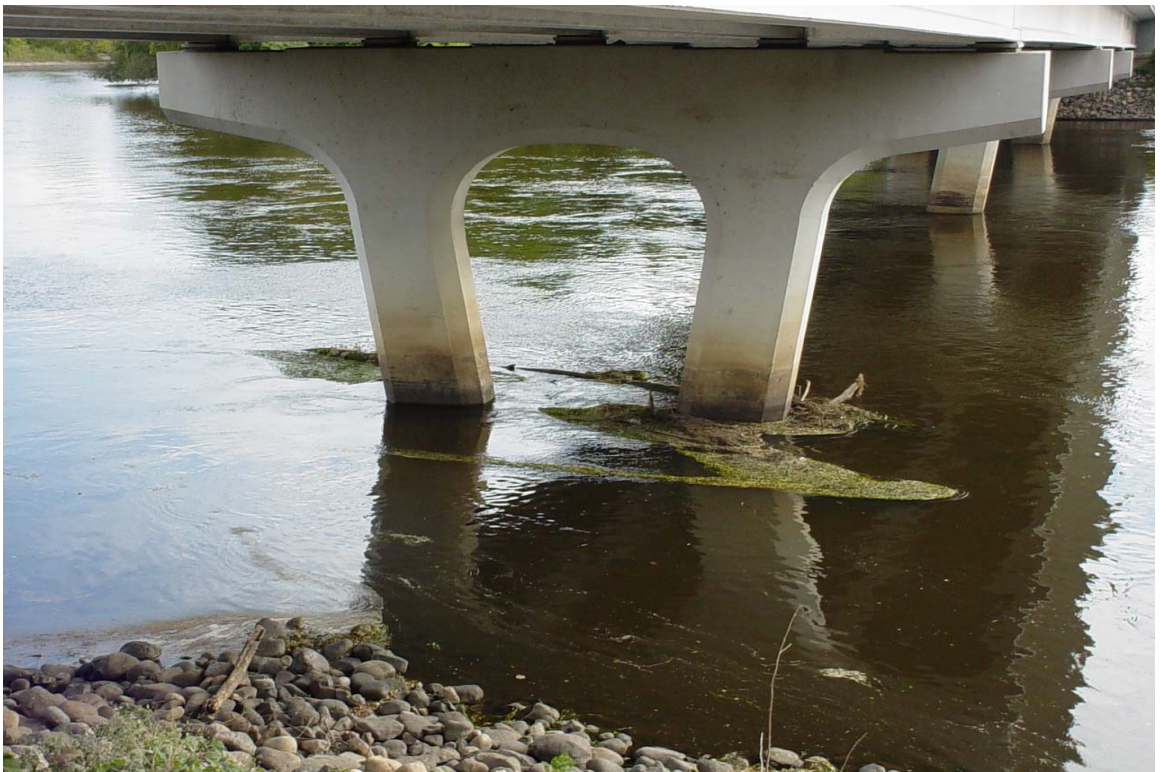
- (D) The top of the footing at Pier 3 was exposed with 5 feet of vertical face exposure at the upstream end, 4 feet along the west side, and 1 foot along the downstream end. There was also 6 inches of undermining along the upstream nose of the footing with 1 foot of probe rod penetration under the footing and no piles exposed.

Photograph 4. View of Pier 3, Looking South.

Scour screening evaluation indicates bridge is stable for scour potential, therefore, monitor scour and footing exposure/undermining during future inspections.
